# **Architectural Tiles: Conservation and Restoration**

## *Butterworth-Heinemann Series in Conservation and Museology*

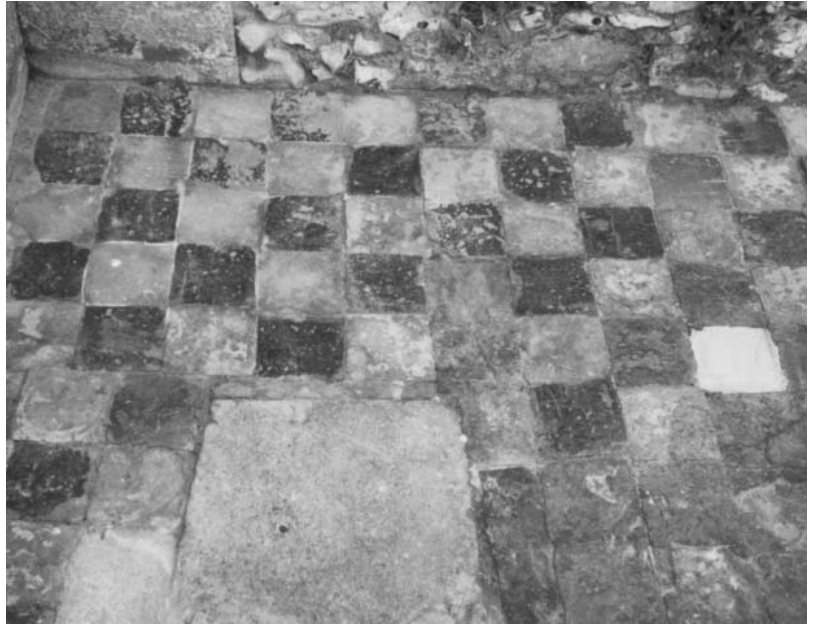
**Figure 1.5**

Chequerboard format found at Thetford Abbey, Norfolk.

Plain tiles set in square-on fashion were often in chequerboard configuration of dark green or black and plain yellow (Figure 1.5). Small pavements of square-on tiles are found arranged in panels of decorated tiles, sometimes of random design, sometimes of repeating pattern. The small pavement located in the south transept chapel at Bylands Abbey is a square-on format with a central roundel, though this form of configuration was probably reserved for important areas.

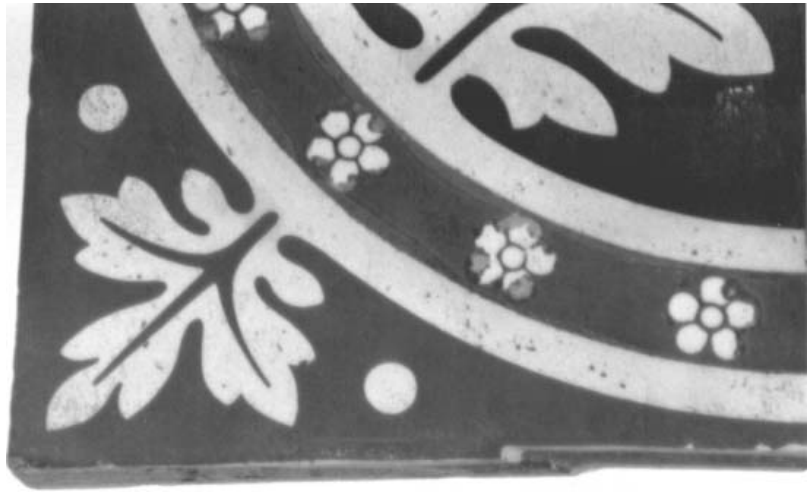
An example of clay slip inlay shrinkage. The blue clay around the white flower motif has shrunk considerably.

are more apt to fracture under movement stress. Plastic clay tiles are more likely to suffer damage to the encaustic pattern in terms of flaking away of parts of the design, the marrying up of the different colours of clay is more difficult to achieve in the wet state, and the technology being in its infancy produced many tiles which were less than perfectly fused. Tiles were frequently used in elaborate floors which are obvious examples of the clay inlay slip shrinking during firing (Figure 2.21).

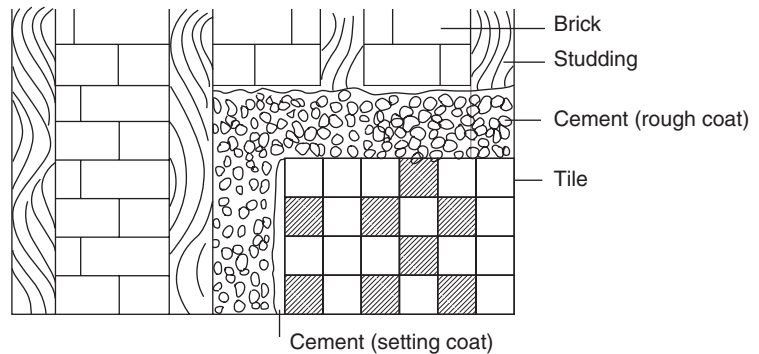
Diagram nineteenth century wall substrate, Furnival.

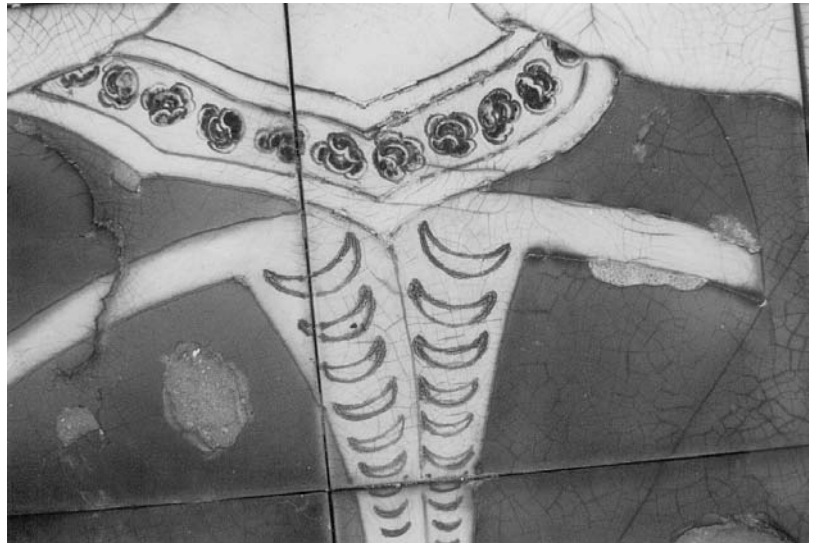
**Figure 3.22**  
Delamination caused by frost  
penetration.

| 3.22 | Delamination caused by frost penetration. | 78 |

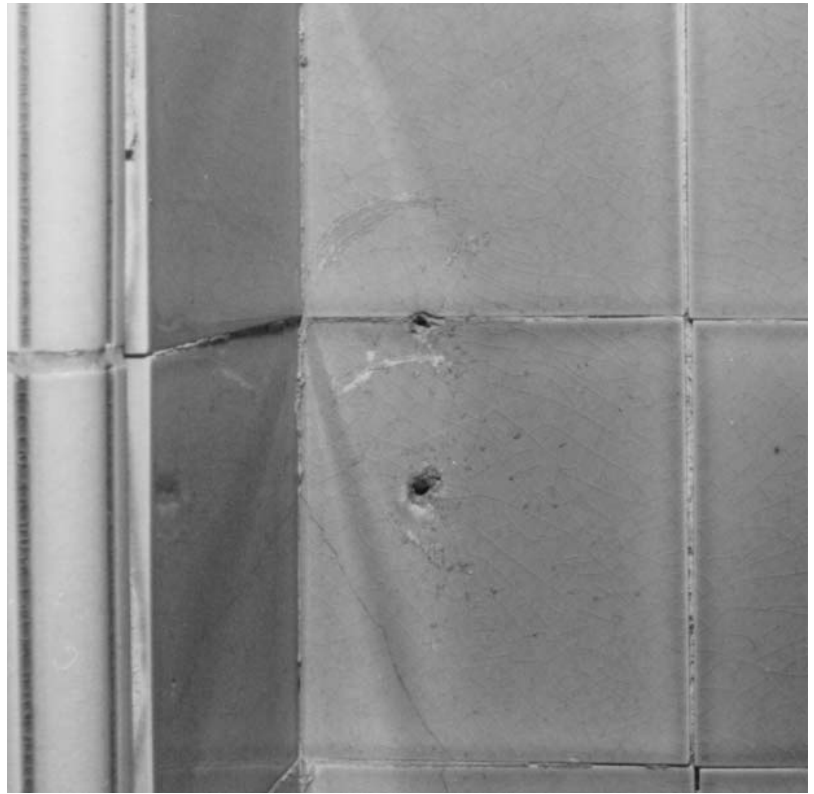
**Figure 5.1**  
Typical damage caused by drilling  
into glazed tiles.

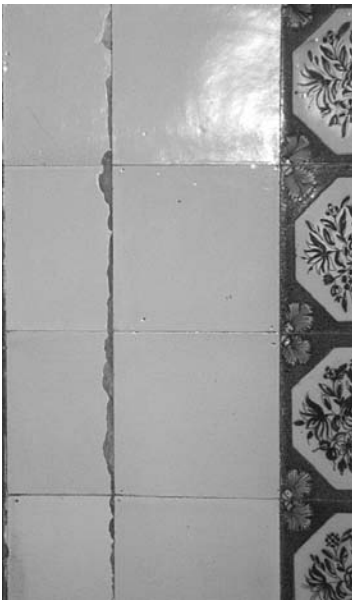
**Figure 5.2**  
Typical damage to the glazed edges  
of delft tiles.

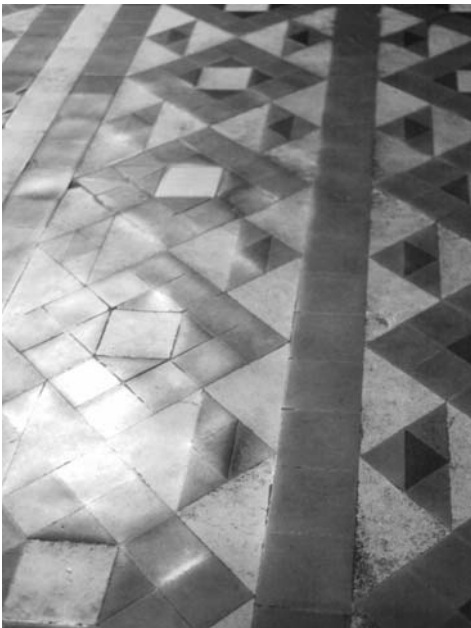
**Figure 5.4**  
Typical damage caused by tread.

Certain forms of damage are part of the natural aging process of the tile surface, for example slight 'dishing' of the surface of floor tiles is a result of prolonged wear against low fired body clay (Figure 5.4). The cause of the dishing derives from having a slightly higher fired temperature at the edges of the tile, the clay body becomes harder

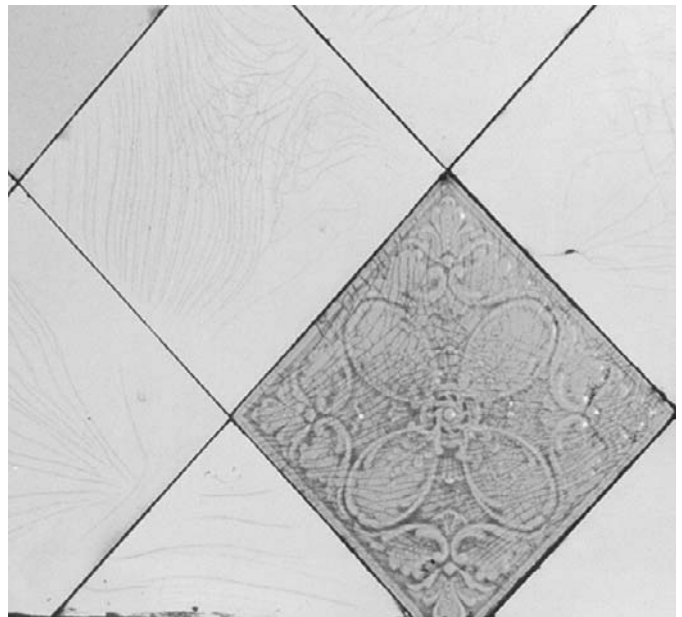
**Figure 5.5**  
Typical crazing on old glazed tiles.

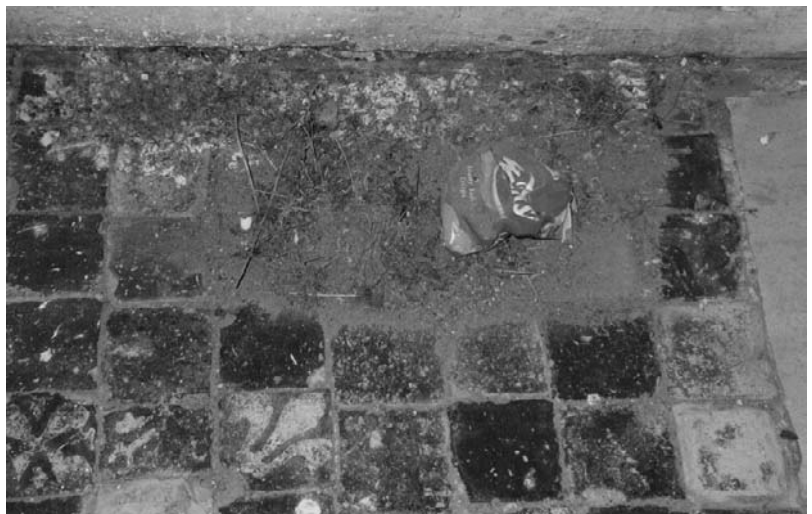
**Figure 5.7**  
Debris on medieval tiles underneath a nest site.

Cleaning medieval tile floors should be carried out only after careful consideration and deliberation, and with the utmost care. The work should not be hurried and constant monitoring of the condition of the fabric of the tile and effect of the chosen method should continue throughout the cleaning process and beyond if possible. Medieval tile floors are most commonly found in ecclesiastical buildings which may be in full use for daily worship or may be scheduled ancient monuments and in full use as visitor attractions. In any circumstances dust and dirt particles will find their way onto the surface of the tiles in considerable quantity. If they are not removed by cleaning, particles will be compressed into the surface of the tile by foot tread causing abrasion and severe wear to the fragile upper surface. Neither are tiles safe even when pedestrians are prevented from walking on medieval floors, although they are plainly at less risk. Birds and bats are often cohabitants of ancient buildings. Acids, nitrates and phosphates found in bird droppings are all harmful to ceramics, and will etch into tile surfaces, particularly when large quantities of droppings are left to build up unchecked under nest sites (Figure 5.7).

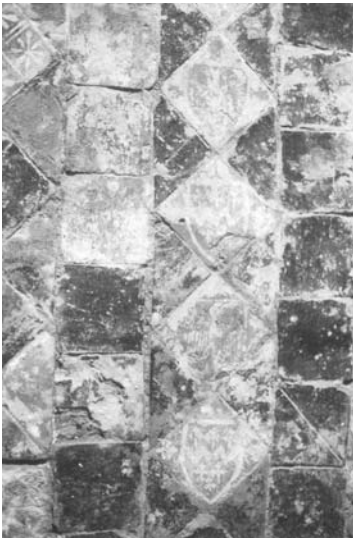
**Figure 5.8**  
Lime encrustations on medieval tiles.

Further problems can be encountered on some medieval tile surfaces. Most ancient ecclesiastical buildings are built using lime mortar, some have their original lime wash wall plaster covering the stonework intact, and some have lost their plaster work completely leaving revealed stonework. Whichever the case there will inevitably be a measure of lime in the dust and debris falling from the wall and gathering on the surface of the tiles adjacent to it and often at some distance, possibly half a metre away from the wall. If these conditions are combined with high moisture levels and continuous slow evaporation either within in the tile body or on the surface, the accumulated lime in the dust particles will react with carbon dioxide in the air and the evaporating water and form hard calcium carbonate encrustations. The process is referred to as carbonation (calcium hydroxide,  $\text{Ca}(\text{OH})_2$ , reabsorbs carbon dioxide,  $\text{CO}_2$ , in moist conditions and reverts to calcium carbonate,  $\text{CaCO}_3$ ) – as a result of this chemical change the encrustations are relatively harder than lime mortar itself (Figure 5.8). If the tile surface is dry then the lime mortar particles remain as dust on the surface. The concretion which is formed adheres to the surface of the tile body in exactly the same way as a mortar and is extremely difficult and sometimes impossible to remove without breaking the fragile ‘soft’ body clay surface to which it is attached. The damage and disfiguration to the tile surface is ruinous. To avoid such irreversible damage regular brushing of the surface of the tile pavement to remove lime mortar dust, using a soft brush, is essential.

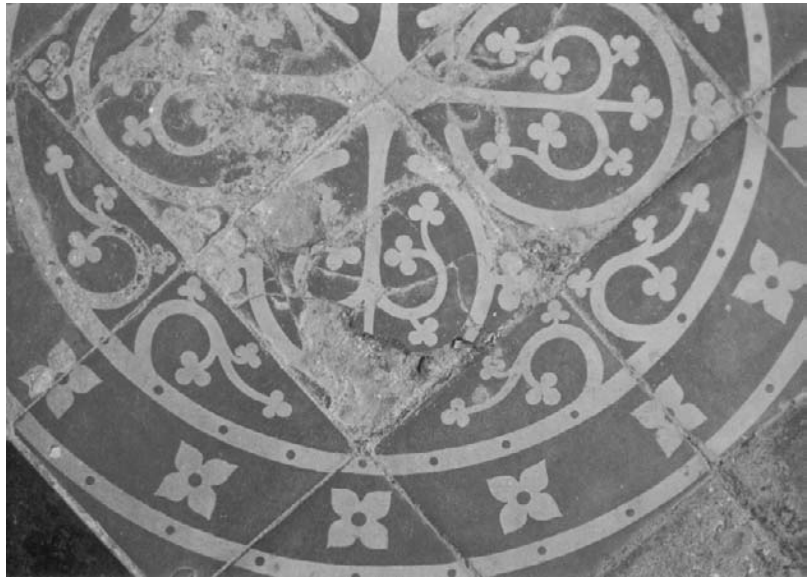
**Figure 5.14**

| 5.14 | Salt damage to the surface of glazed tiles caused by constant leaching of water from above. | 115 |

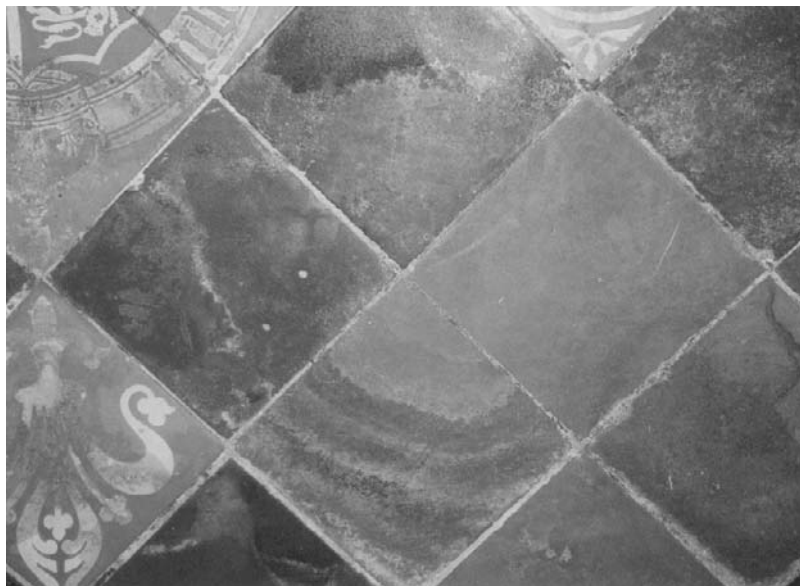
**Figure 5.15**

| 5.15 | Residue of salt damage caused by slow evaporation. | 116 |

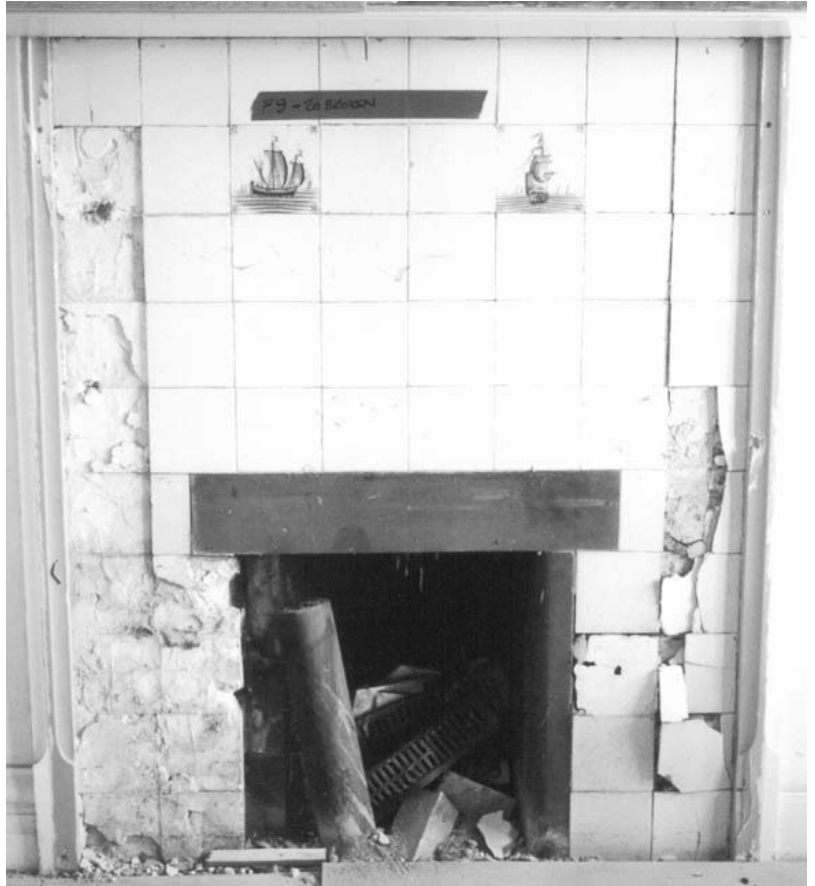
**Figure 5.18**

| 5.18 | Degraded lime plaster adhesive in a delft tile fireplace. | 120 |

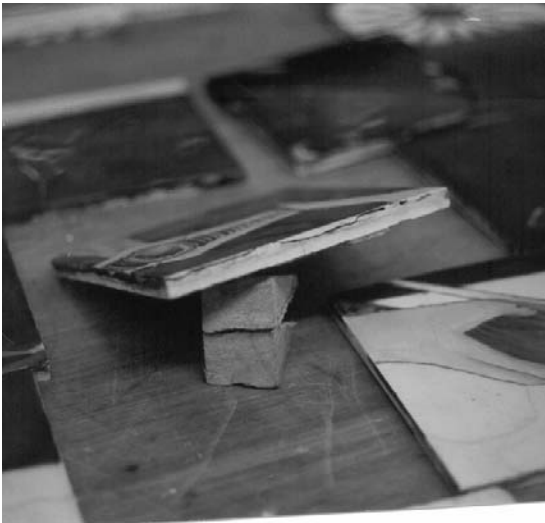
**Figure 5.22**  
Delamination due to frost action.

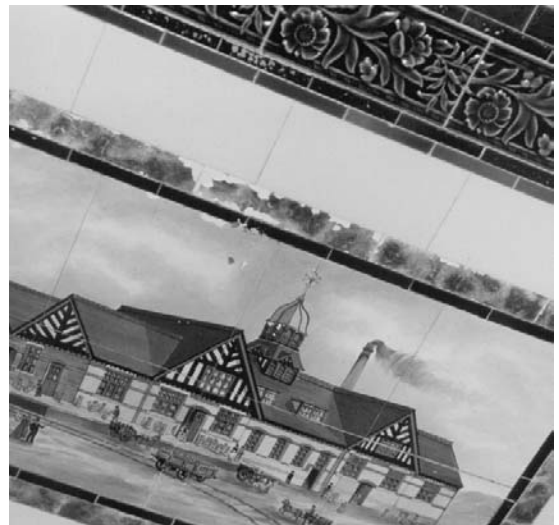
**Figure 5.23**  
Spontaneous shedding of glaze due to tensile pressure.

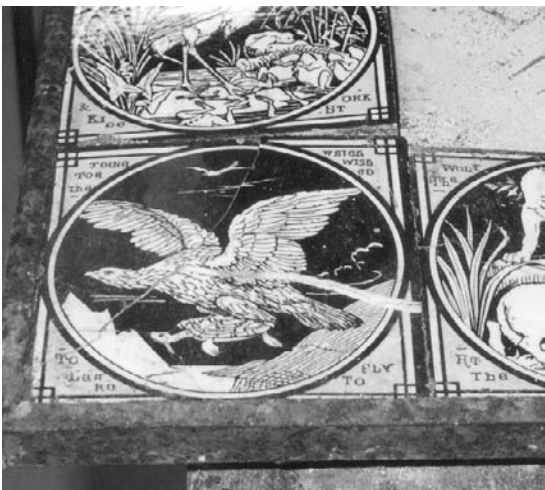
**Figure 5.24**  
Fracturing caused by corrosion expansion.

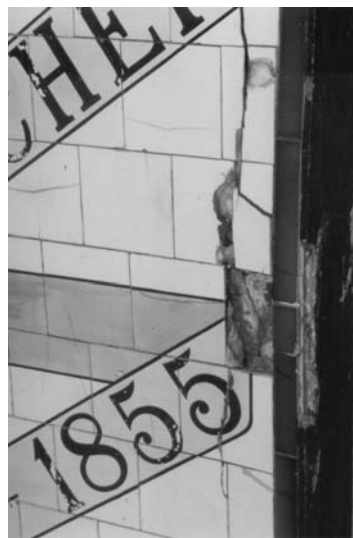
**Figure 5.25**  
Compressive tension and shifting causing fracturing and misalignment.

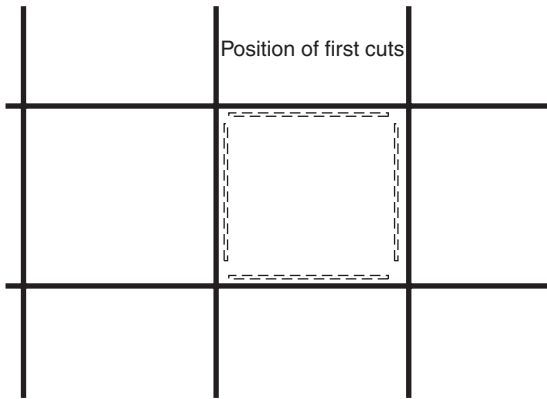
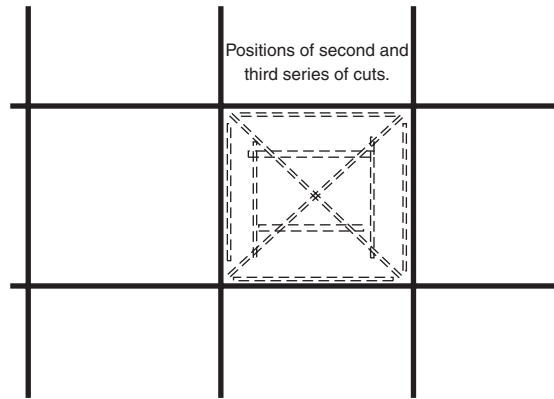
**Figure 5.30**  
Diagram to illustrate removal of damaged historic tiles.

**Figure 5.31**  
Diagram to illustrate removal of damaged historic tiles.

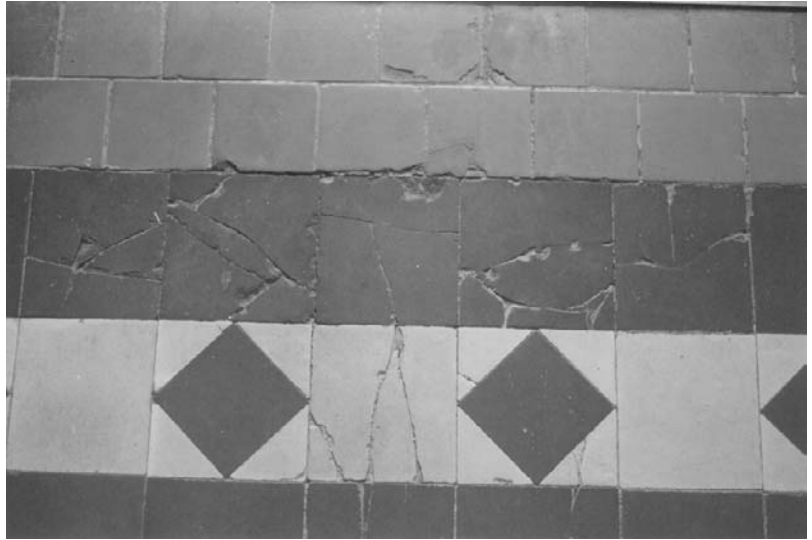
**Figure 7.5**

| 7.5 | Impact fracture. | 159 |

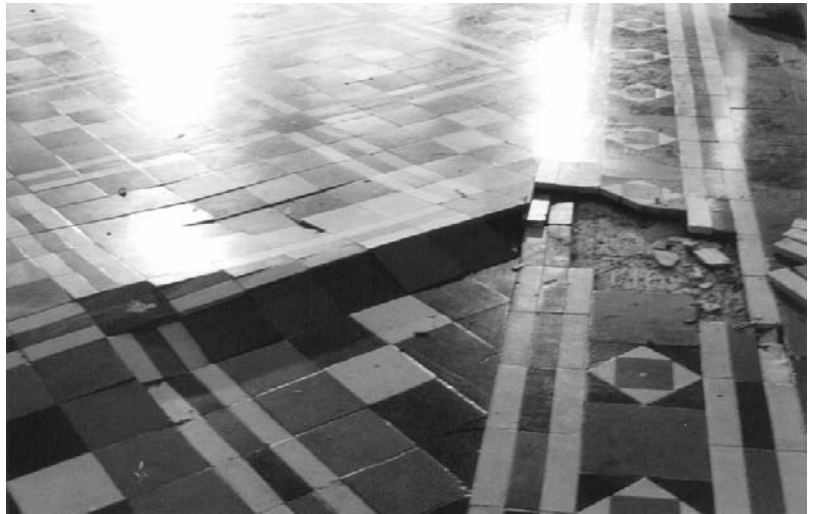
**Figure 7.8**

| 7.8 | Differing sizes found in original tiling which had been cut to fit. | 161 |

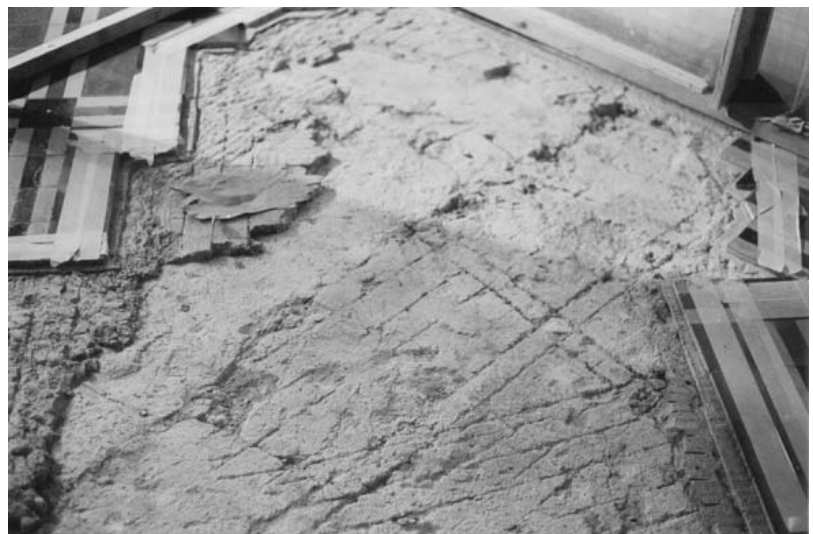
**Figure 7.11**  
Fracturing in the lower screed.

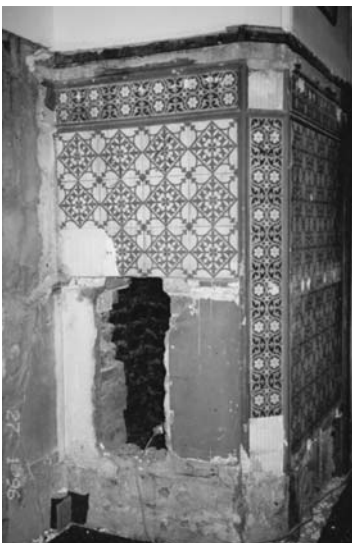
**Figure 7.13**  
Damage to scheme caused by the letting in of heating ducts to walls.

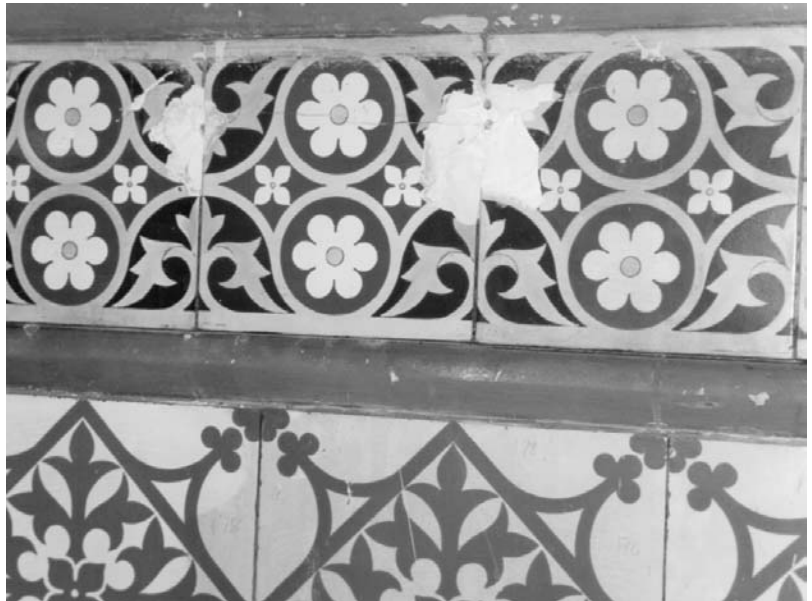
**Figure 7.14**  
Damage caused by steel pins  
hammered into tiles.

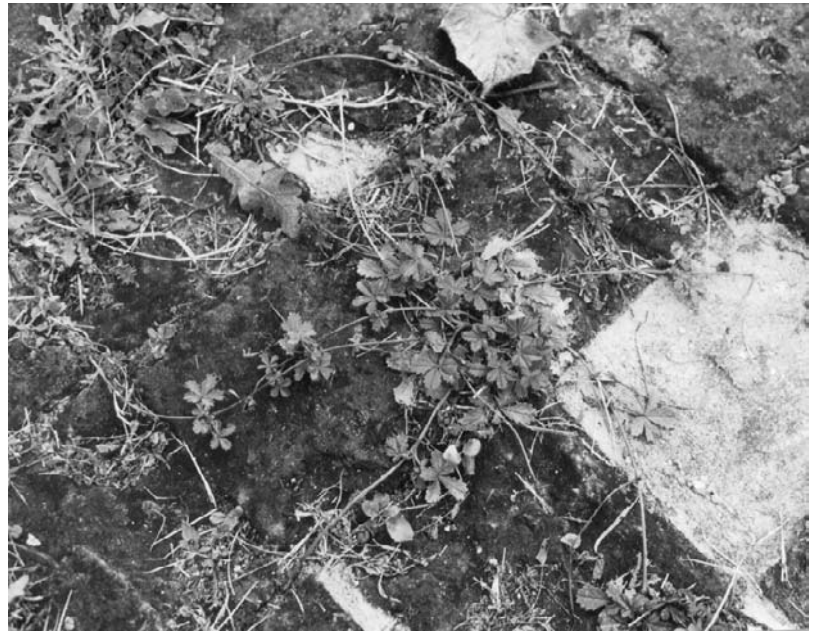
**Figure 7.16**  
Damage caused by weed growth.

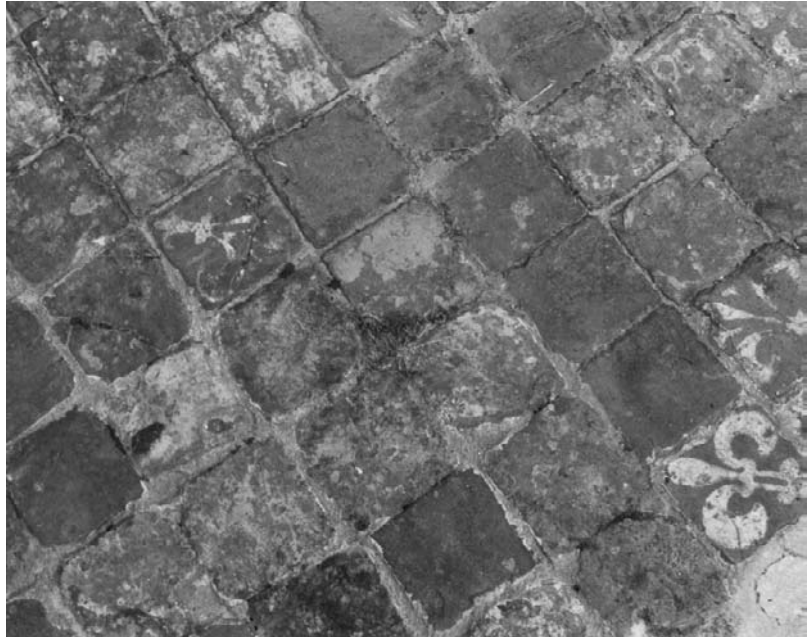
**Figure 7.18**  
Lime mortar 'buffer' zone.

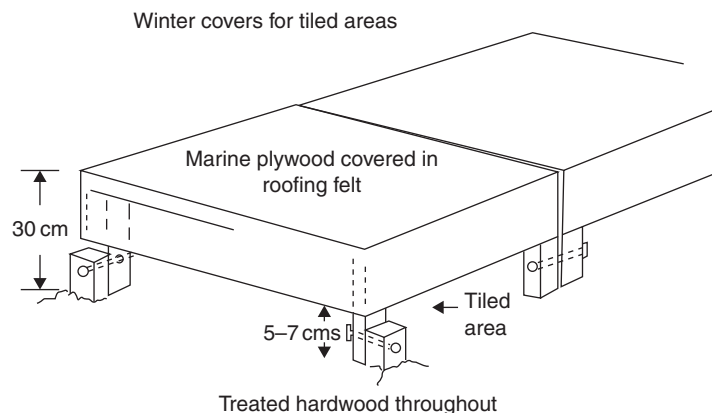
**Figure 7.20**  
Diagram of winter covers.
